Manhole Inspection Summary

Manhole # S31EE2010MH

Location Address: **5618 SAINT ALBANS WAY**

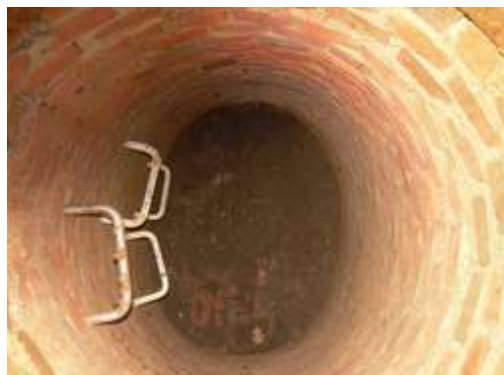
Top View

Channel debris.

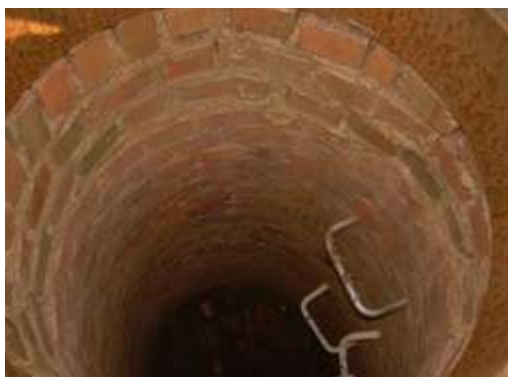
Defect

Adjustment deterioration, loose brick, and infiltration. Barrel infiltration - other side.

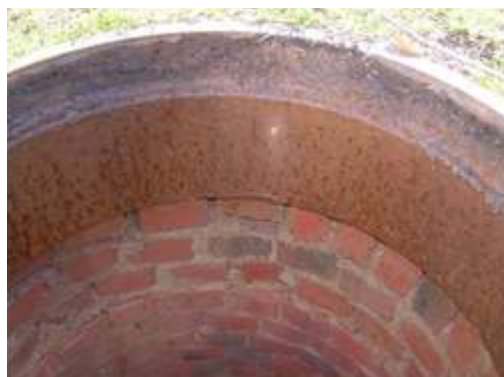
Defect

Adjustment deterioration, loose brick, and infiltration.

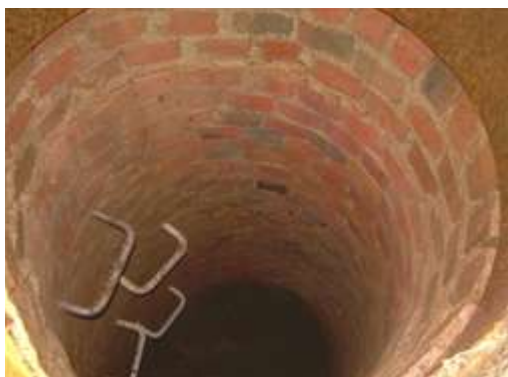
Defect

Adjustment deterioration and infiltration. Barrel infiltration

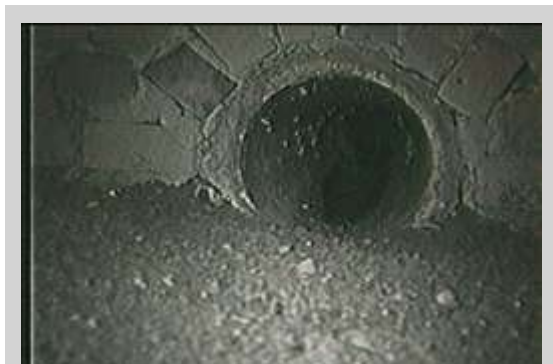
Pipe Out @ 12 O'Clock

Deposits: ☐ None ☒ **Mud** ☐ Sludge ☒ **Debris** ☐ Grease

Silt Depth: **0.5** (in.)

Deposits Extent: **Light**
